Manhole Inspection Summary

Manhole # S67K__011MH

Insp Date: **1/2/09 5:38 AM**

Location Address: **901 Dundalk Ave.**

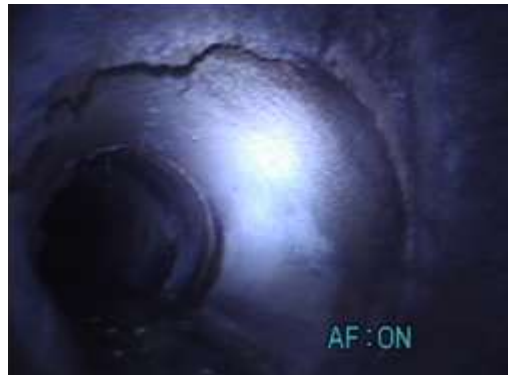
Defect 1

pipe seal cracked l6 at 1 o'clock

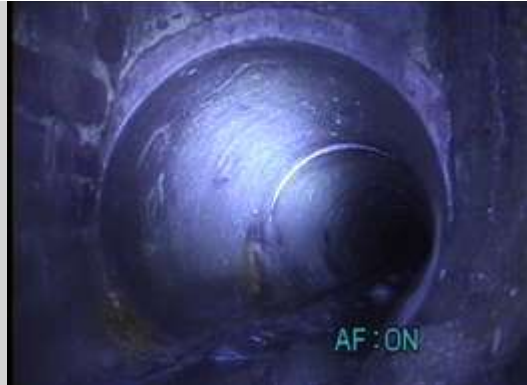
12 O'Clock Outflow

18 in. Circular Gravity Sewer
Pipe Out @ 12 O'Clock

Pipe Height: **18** (in.) Rod and Bar (Angled)
Pipe Material: **Clay** ☐ Pipe Lined
Invert Depth: **15.92** (ft.) Flow Characteristics: **Slow**
Deposits: ☐ None ☐ Mud ☐ Sludge ☒ **Debris** ☐ Grease
Silt Depth: **0.25** (in.) Deposits Extent: **Light**
Infiltration: **None** Pipe Seal Cond: **Sound**

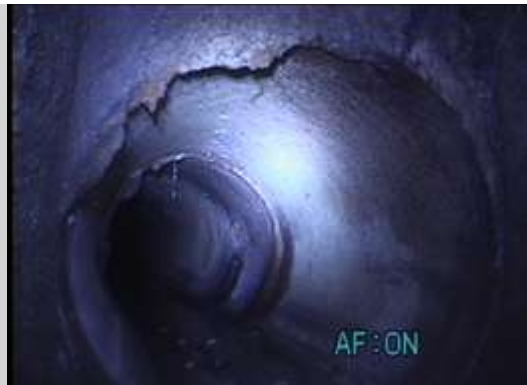
6 O'Clock Inflow

18 in. Circular Gravity Sewer
Pipe In @ 6 O'Clock

Pipe Height: **18** (in.) Rod and Bar (Angled)
Pipe Material: **Clay** ☐ Pipe Lined
Invert Depth: **15.50** (ft.) Flow Characteristics: **Slow**
Deposits: ☒ **None** ☐ Mud ☐ Sludge ☐ Debris ☐ Grease
Silt Depth: (in.) Deposits Extent:
Infiltration: **None** Pipe Seal Cond: **Cracked**
